STANDARD STRUCTURAL PEST CONTROL INSPECTION REPORT
(WOOD-DESTROYING PESTS OR ORGANISMS)

ADDRESS OF PROPERTY INSPECTED	BLDG. NO.	STREET	CITY	DATE OF INSPECTION
11730		Graystone	Norwalk	9-8-72
FIRM NAME AND ADDRESS			CO. CODE	
TERMITE SERVICE CO. 13116 DE ALCALA DR. LA MIRADA, CALIF.			19-5389

General Description One level frame & stucco residence with composition roof and detached garage.

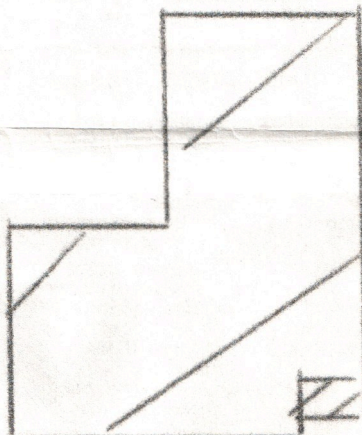
DIAGRAM AND EXPLANATION OF FINDINGS (This report is limited to structure or structures shown on diagram.)

- This is to certify that the above property was inspected on the date indicated, in accordance with the Structural Pest Control Act Rules and Regulations, and that no evidence of active infestation, infection or adverse conditions were found.
